SHADOW LAKE DAM

NJ 00090

PHASE 1 INSPECTION REPORT NATIONAL DAM SAFETY PROGRAM

March, 1979

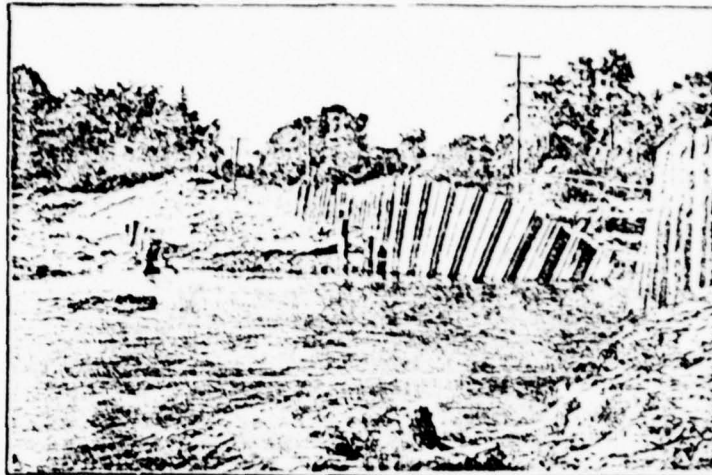
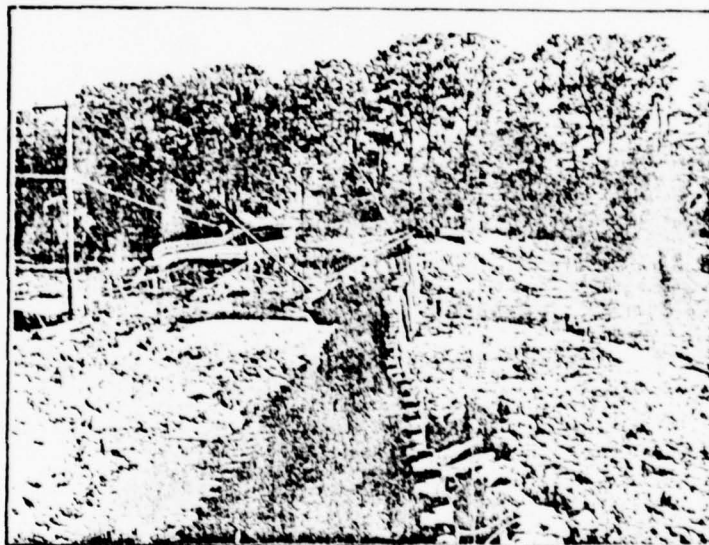
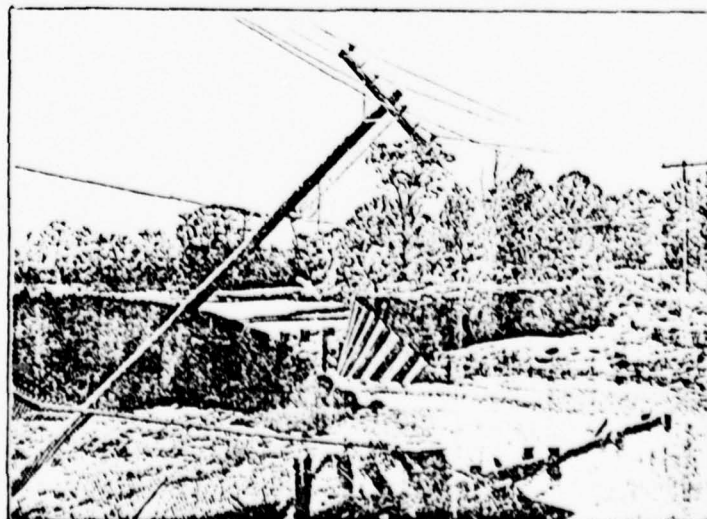
1938
FAILURE
Figure 4

Looking North

Looking South

Breached Area

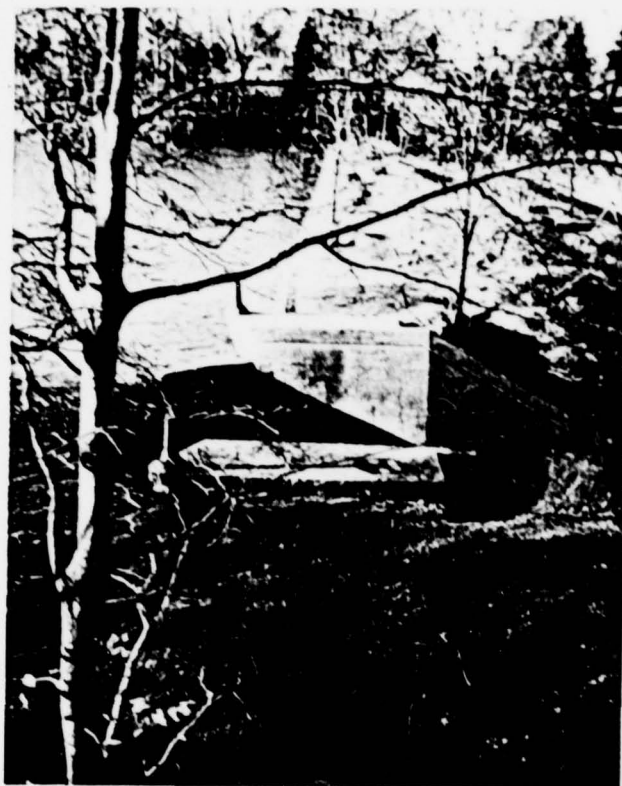
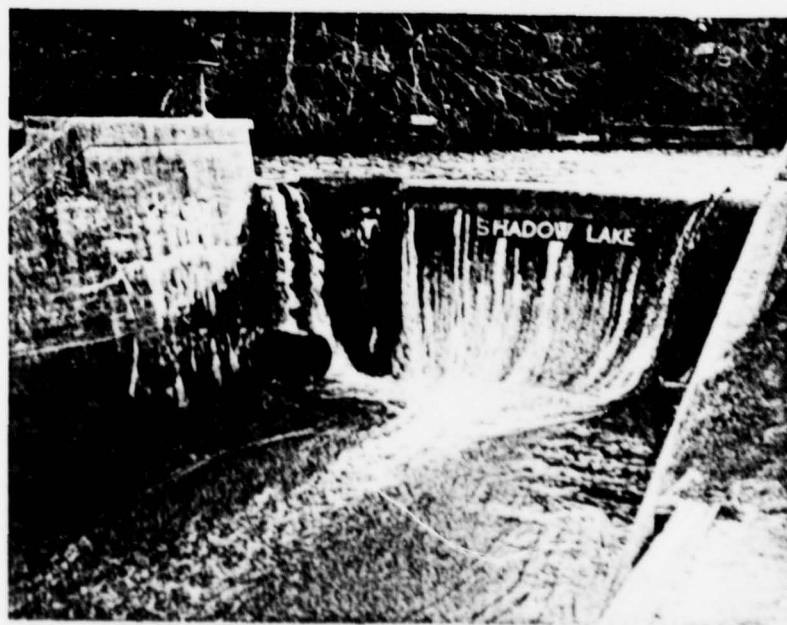
The two spillways exhibit some weathering reflecting their age but are in basically sound structural condition. The main circular crest has a 23-foot depressed notch in the center portion of the overflow lip and the sides, which are about 6 inches higher, are badly spalled and cracked. However, the overall structure appears in an integral condition with no differential settlement or tilting observed.

Main Spillway

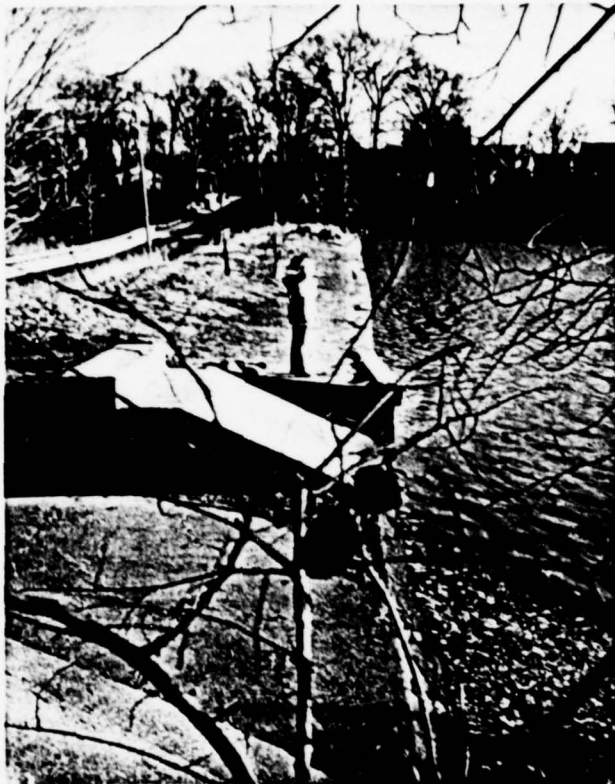
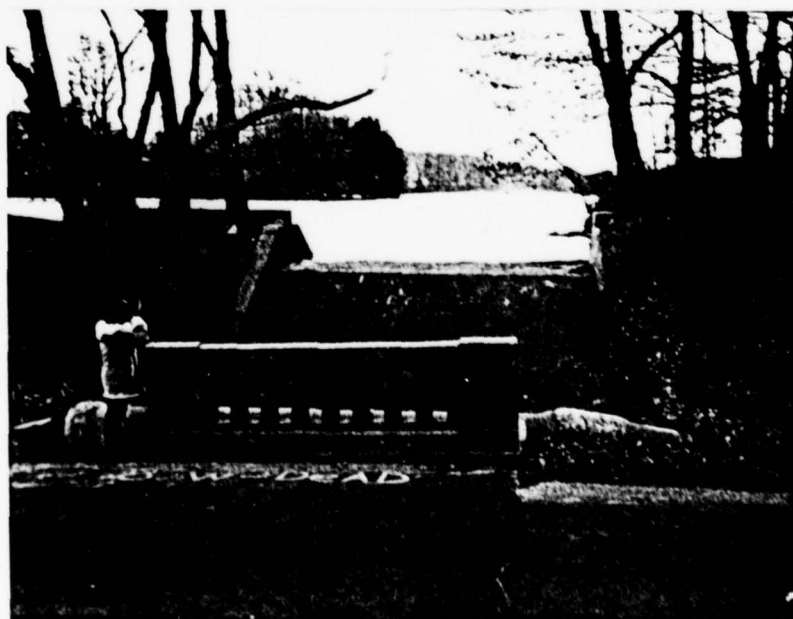
The auxiliary spillway is also in a sound structural condition with only minor superficial cracking in the apron slab. The wing-walls which extend east to the roadway culvert are in good condition and have 4" weepholes near their base. These walls tie into the box culvert at roughly roadway profile grade. Discharge from the auxiliary spillway flows across a broad crested weir directly into an old 5'x9' concrete box culvert under Swamp Nut Road. This culvert has experienced some type of foundation failure and is displaced laterally several inches downstream. Although it shows only minor cracking, the northwest and southeast corners have settled several inches. Similar to the main spillway, heavy discharges over the auxiliary spillway, especially if occurring during a high tide, would quite possibly flow over the road.

| VISUAL EXAMINATION OF | OBSERVATIONS | REMARKS OR RECOMMENDATIONS |
|---|---|---|
| SEE PAGE ON LEAKAGE | Seepage through cracks at toe of apron of auxiliary spillway. | Timber retaining wall on left side of auxiliary spillway shows early stages or rotting. |

Auxiliary Spillway
(Looking South)

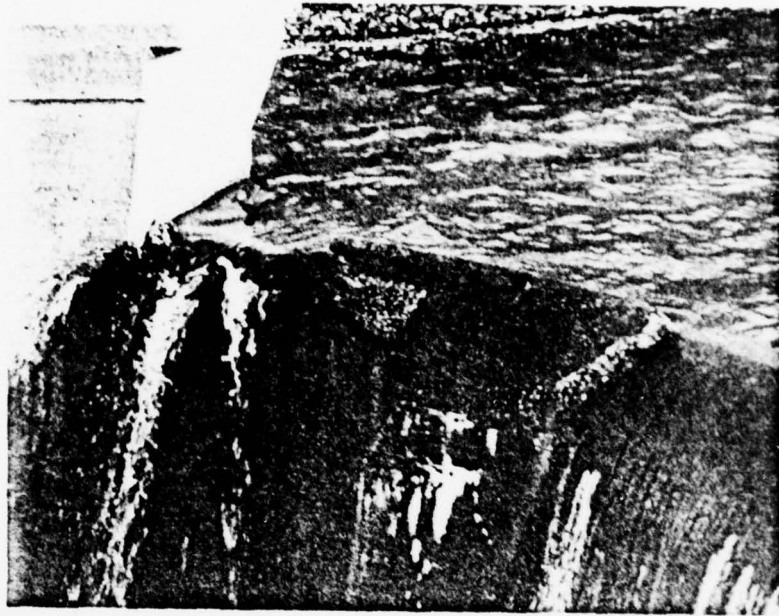
| VISUAL EXAMINATION OF | OBSERVATIONS | REMARKS OR RECOMMENDATIONS |
|---|---|---|
| SURFACE CRACKS CONCRETE SURFACES | Main spillway: Deterioration of crest lip. Extensive spalling of upstream face of weir at waterline. Auxiliary spillway: Superficial cracks on spillway as well as some spalling on broad crested weir. | Approximately 2½' section of lip has broken off on main spillway. |

Deterioration of main spillway crest

On the basis of the present conditions and structural geometry, improvements to the existing spillways are not warranted. The deteriorated areas of the concrete work should be patched, especially on the top of the curved ogee crest of the main spillway.

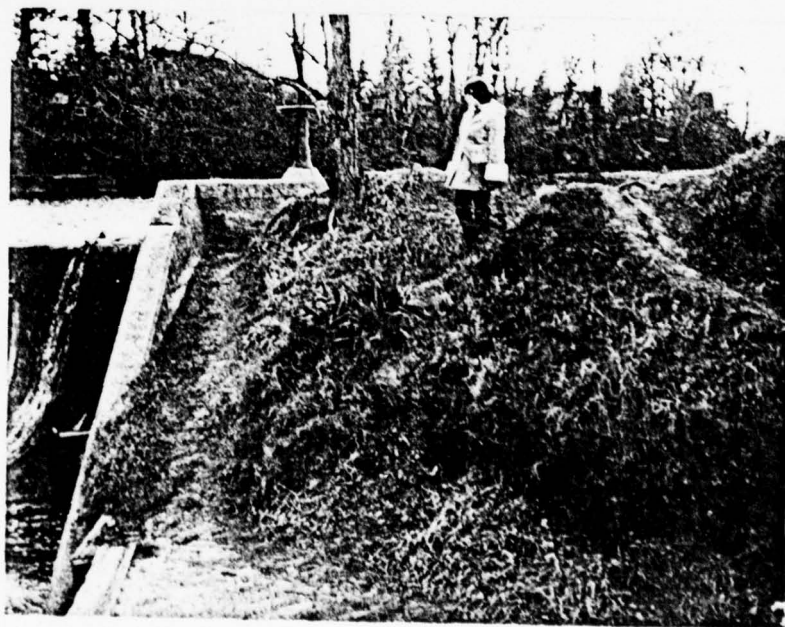
The embankment portion and timber bulkhead were found to be in a satisfactory condition and stable except for deep erosion which has developed behind both wingwalls of the main spillway. The backslopes are covered with grass and occasional bushes. The alignment of the bulkhead is slightly distorted but is in overall good condition. Minor sections of the timber whalers are rotted but this could be easily repaired. There was little evidence of any seepage, although much of the backslope area was frozen. Water was flowing into the auxiliary spillway through a CMP in the north wingwall. It could not be determined whether this was a cut-off pipe outlet or a roadway drain. From earlier records, it is doubtful that any cut-off drains were ever installed. The sloughed areas at the toe of the backslopes are of minor concern and could possibly be caused by clogged roadway drains and vehicular splashing rather than a result of seepage. Water appears to have accumulated in several low areas on the west pavement edge.

| VISUAL EXAMINATION OF | OBSERVATIONS | REMARKS OR RECOMMENDATIONS |
|---|---|---|
| JUNCTION OF EMBANKMENT AND ABUTMENT, SPILLWAY AND DAM | Satisfactory but very poor condition at sides of main spillway. Some erosion behind abutment. | Should be protected with slope paving. |

Erosion behind left wingwall of main spillway

c. Regrade and protect with slope paving, the downstream embankment at the spillway wingwalls.

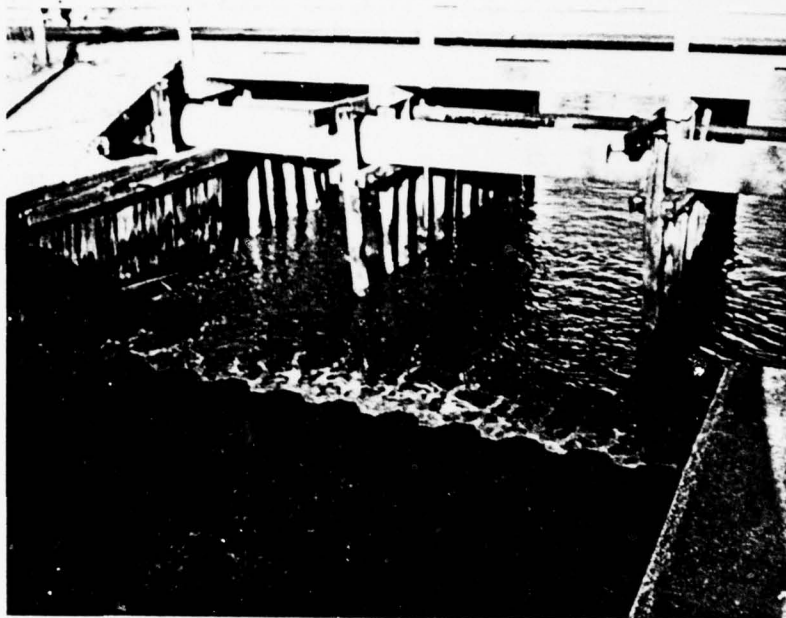
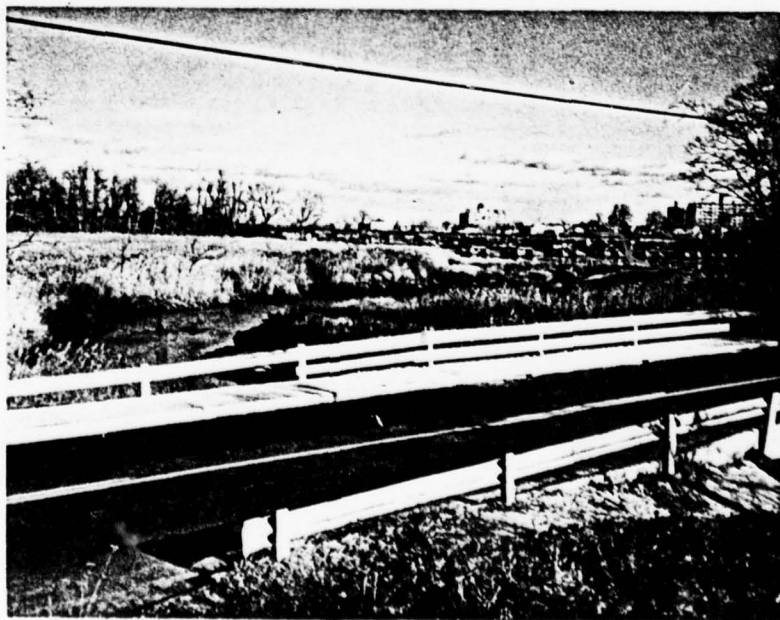
The 24" sluice gates are located on each side of the spillway and discharge directly onto the circular sill below. They appear to be operable. Discharge from the spillway apron flows directly into the Navesink River tidal marshland immediately to the east thru a timber trestle structure under Nut Swamp Road. This bridge is hydraulically inadequate to handle the spillway discharge and is of dubious structural strength. A 20" water main is carried along the west fascia which additionally restricts the hydraulic opening.

| VISUAL EXAMINATION OF | OBSERVATIONS | REMARKS OR RECOMMENDATIONS |
|---|---|---|
| BRIDGE AND PIERS | Satisfactory but hydraulically restricted. | Bridge below auxiliary spillway has foundation failure at NW corner (settled 4"+). Road bridge below main spillway hydraulically blocked by 24" line. |

Bridge below Main Spillway

g. An engineering investigation should be made of the hydraulic capacity of the downstream Nut Swamp Road bridges in cooperation with the owner of these structures. This investigation should determine the necessity of developing remedial measures to increase the hydraulic capacity of the timber trestle and box culvert to adequately pass the spillway discharges from the dam.
